**Second  
International Conference  
on  
Case Histories in  
Geotechnical Engineering**

**June 1-5, 1988**

**University of Missouri-Rolla  
Rolla, Missouri**

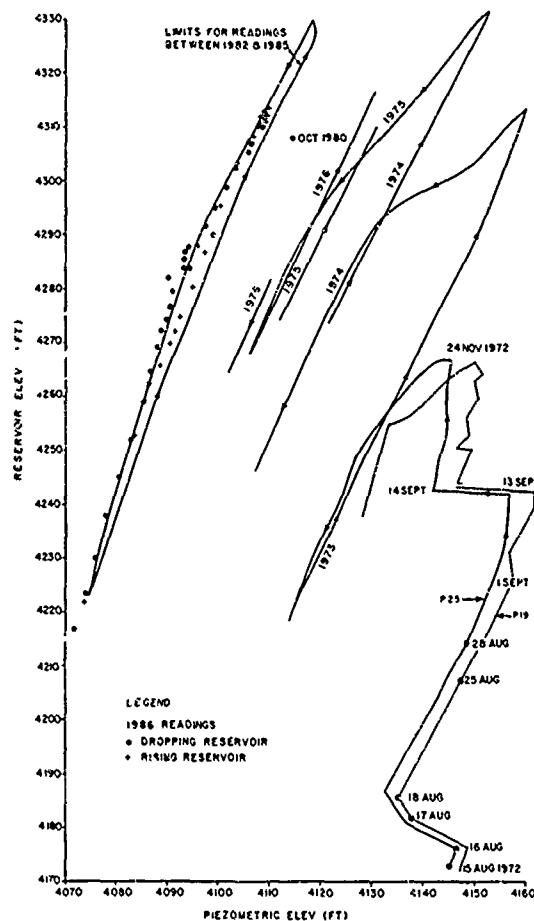
Over the years the piezometric levels in the alluvium immediately upstream of the cut-off gradually decreased until about 1982 when steady-state conditions were reached (Figure 8). Readings from piezometer P19,

Fig. 8 Piezometric heads in P19 and P25

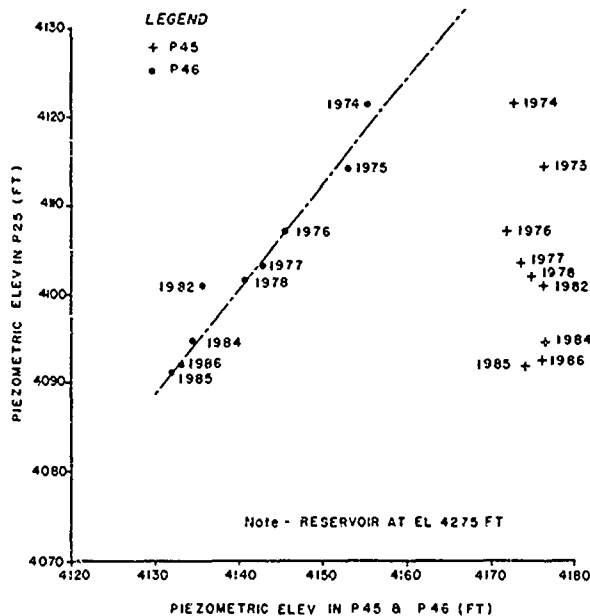
Fig. 9 Hydraulic connection between P46 and P25

Since about 1982, however, P25 readings have varied monotonously with reservoir level. This phenomenon is considered to be the result of either stabilized seepage conditions in the alluvium adjacent to wall apertures, or an increase in reservoir sedimentation or a combination of both effects. Records from piezometers P45, P46, P47 and P48, 100 ft farther upstream, are not particularly useful in explaining the current steady-state conditions across the wall. P46 readings indicate an hydraulic connection exists between this piezometer and P25, whereas piezometric levels in P45, P47 and P48 have remained relatively constant over the years (Figure 9). The linear relationship between P25 and P46 is not surprising as these piezometers appear from preconstruction river valley contours to lie in the main river channel. P45, P47 and P48, on the other hand, are located in the flood plain on either side of the main channel where less pervious sediments could be expected as a result of lensing and beaching effects.

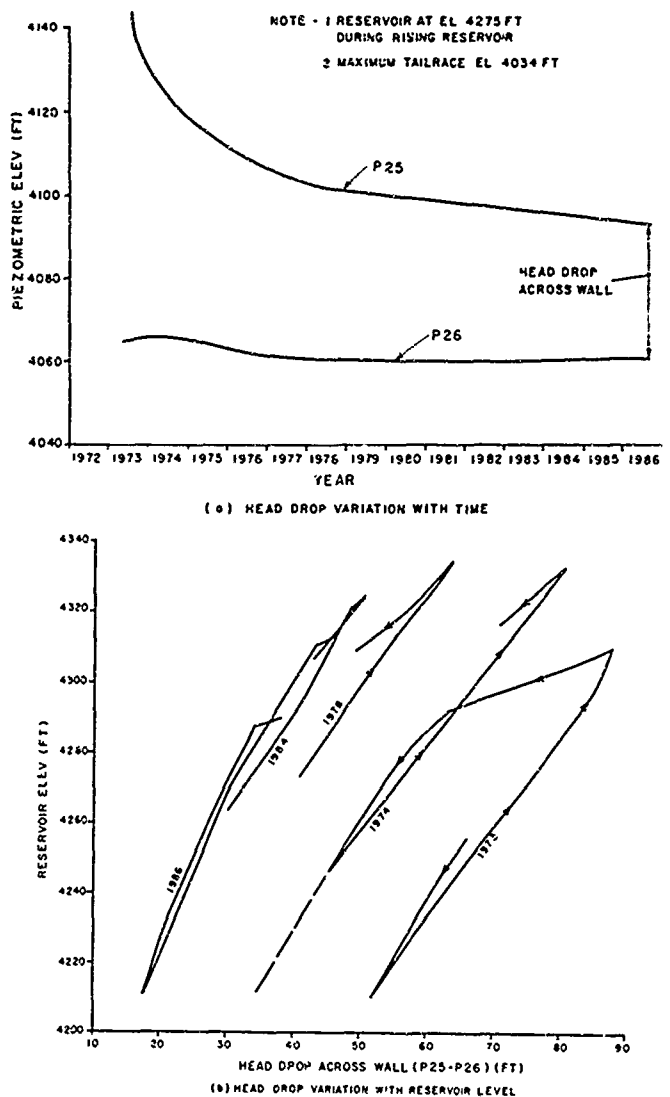
An indication of the performance of the cut-off wall is illustrated on Figure 10. Except for erratic variations during the first few months following reservoir filling, the head drop across the wall has declined at a decreasing rate over the years until the early 1980's when conditions more or less stabilized (Figure 10a), varying only with reservoir elevation (Figure 10b). Downstream of the cut-off wall, the piezometric profile through the bottom of the chimney drain and underlying alluvium (Figure 11) indicates that hydrostatic conditions with heads 25 to 30 ft. higher than the tailrace level have prevailed in the alluvium since 1973. However, pneumatic piezometer G32, located in the chimney drain, denotes pressures in excess of hydrostatic suggesting the native sands and gravels are more pervious and acting as an

Fig. 10 Head drop across the cut-off

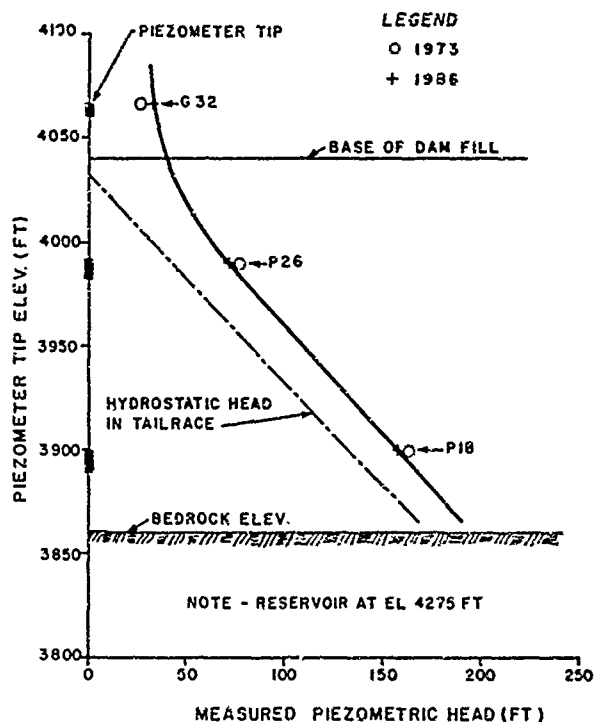
Fig. 11 Piezometric profile through alluvium downstream of cut-off

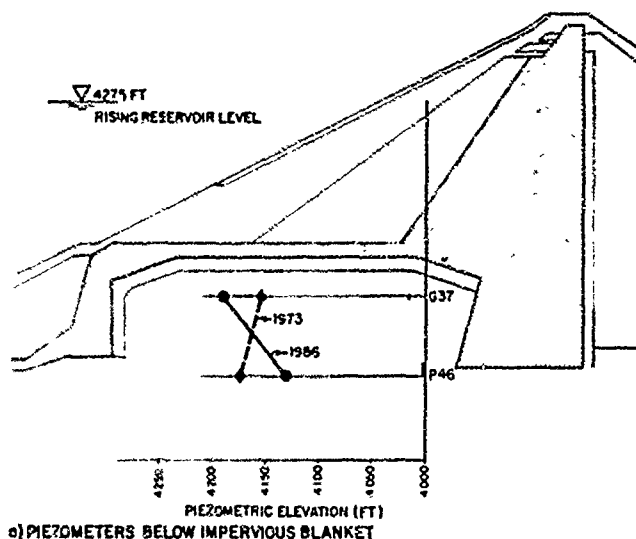
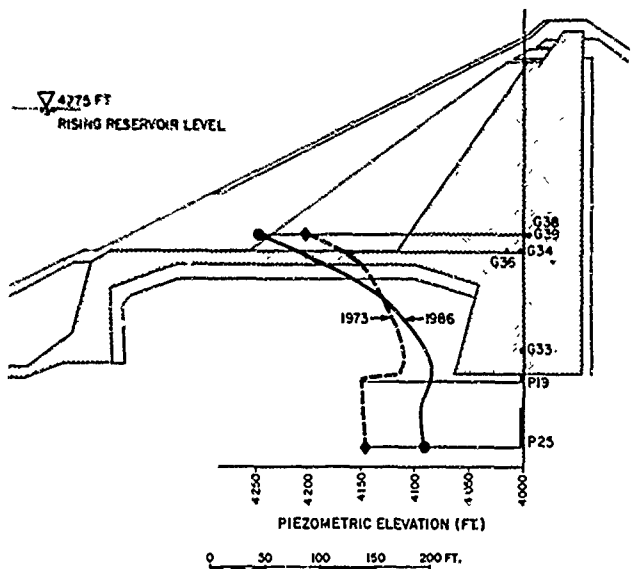
a) PIEZOMETERS BELOW IMPERVIOUS BLANKET

b) PIEZOMETERS IN DAM CORE

Fig. 12 Piezometric profile in embankment upstream of cut-off

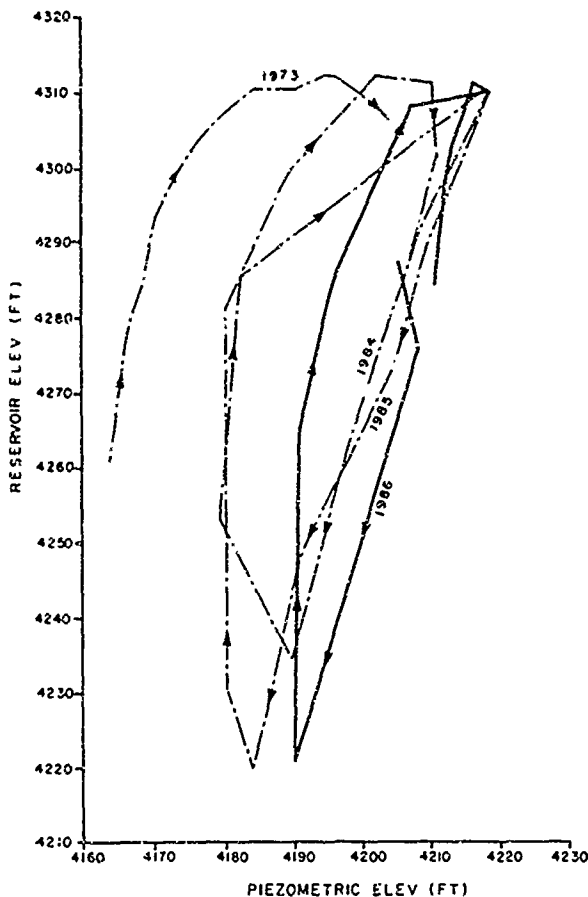
Fig. 13 Hysteresis effects in G37

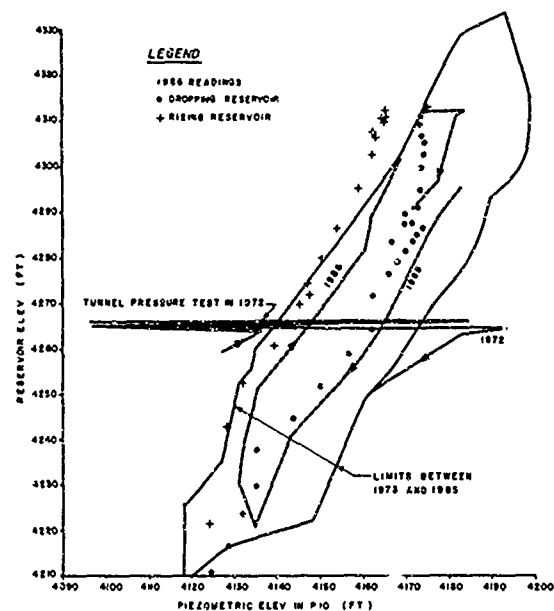
Fig. 14 Piezometric heads in north abutment

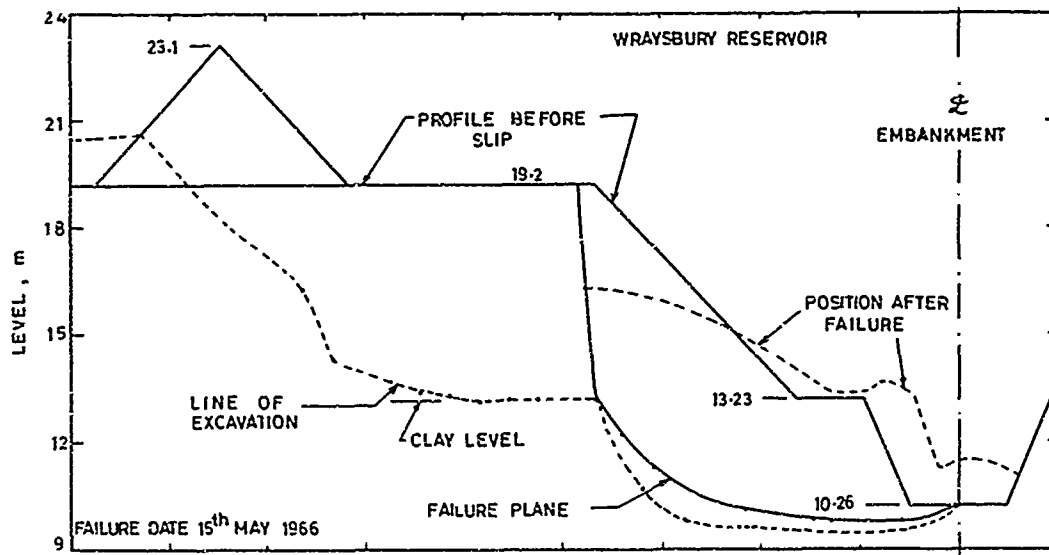
FIG. 1 - CROSS SECTION OF THE SLIP FAILURE AT 2 CHAINAGE 3684.9 m

The short term slip occurred at chainage of 3684.9 m. The slip took place three days after opening of the complete excavation. The approximate shape of the slip has been shown in Fig. 1. The undrained strength mobilised along the slip surface was found by taking unit weights of gravel and clay as  $2.083 \text{ t/m}^3$  and  $1.923 \text{ t/m}^3$  respectively. The undrained strength mobilised in clay was  $3.082 \text{ t/m}^2$  without considering the strength of gravel. If the strength of gravel is considered, the mobilised strength in the clay would have been lower. The average water content of the mass of soil along slip surface in clay was 29.3 percent.

It can be seen from Fig. 1 that the most of the field slip surface in the clay was nearly horizontal. This means that the most of the strength mobilised should correspond to the strength measured on samples tested with their axis at  $45^\circ$  and  $56^\circ$  to the vertical. The undrained strength along the slip surface before failure may not be constant along the length of the slip surface but may be dependent upon the orientation and the length of the rupture surface at any particular orientation.

Based on the assumption that the angle made by failure plane with respect to horizontal in the triaxial sample is  $56^\circ$ , irrespective of the orientation of the sample, the actual rupture surface, Fig. 1, can probably be divided into three sections approximately of length of about 10 to 15% - Section I, about 75 to 85% - Section II and about 0 to 5% of

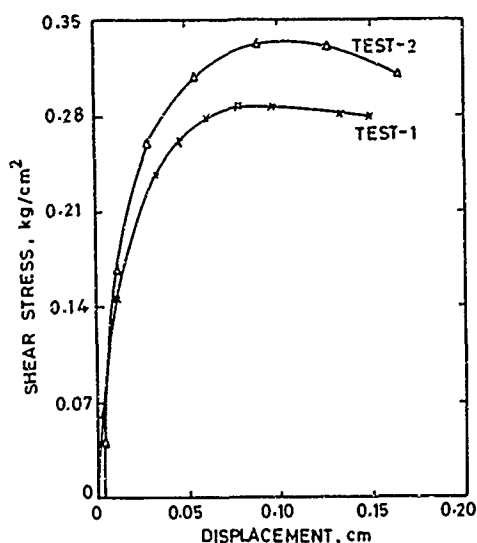
FIG. 2 - USB TESTS 6cm x 6cm SAMPLES WITH SHEARING ALONG FIELD SLIP SURFACE

One undisturbed block sample of clay with the slip surface at mid height was taken from the site. Two undisturbed samples of size 6 cm x 6 cm were prepared for direct shear box test with the slip surface at about mid height. The undrained shear tests were run on these samples causing shearing along the slip surface in the tests. The stress displacement curves are given in Fig. 2. The results of the tests are given in Table 1.

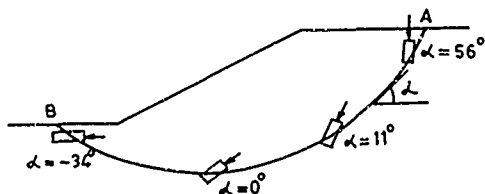
FIG. 3 - ORIENTATION OF RUPTURE SURFACE

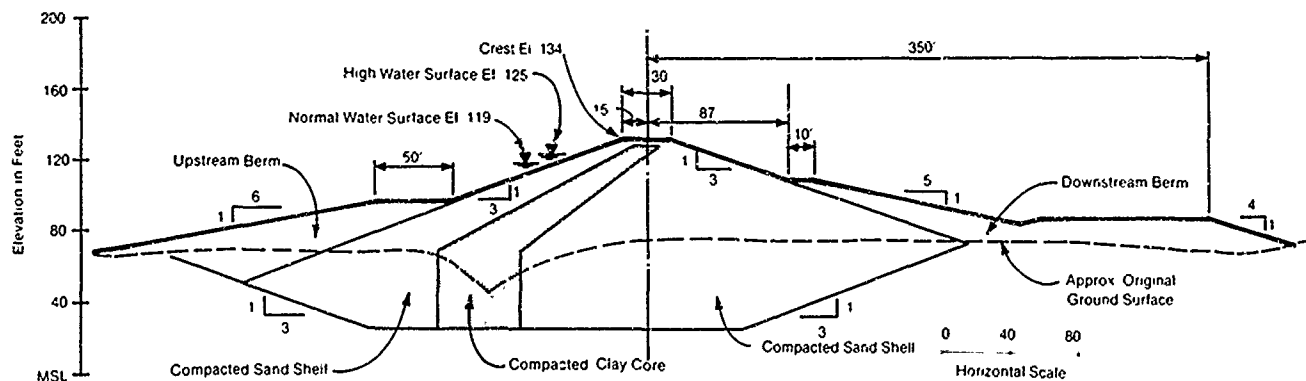
Fig. 3  
MAXIMUM DAM SECTION

The dam section is shown in Figure 3. An upstream-sloping core was chosen to provide a large drained downstream shell for improved stability under earthquake conditions. The core was constructed of dispersive clay

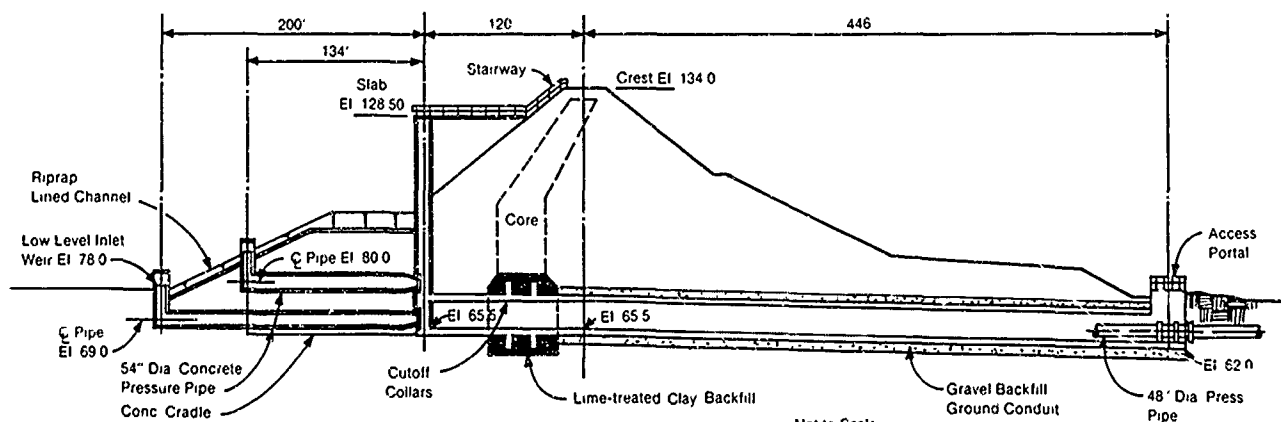
Fig. 4  
OUTLET CONDUIT PROFILE

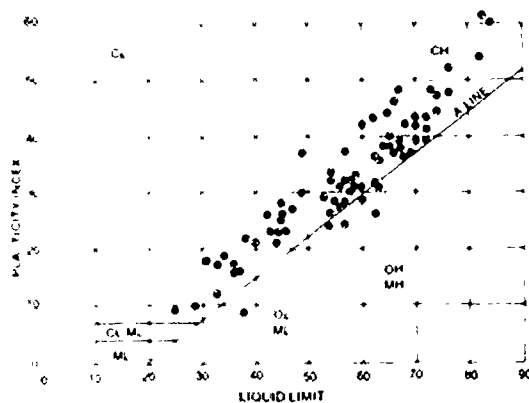
Fig. 5  
UPPER CAPARO CLAY PLASTICITY

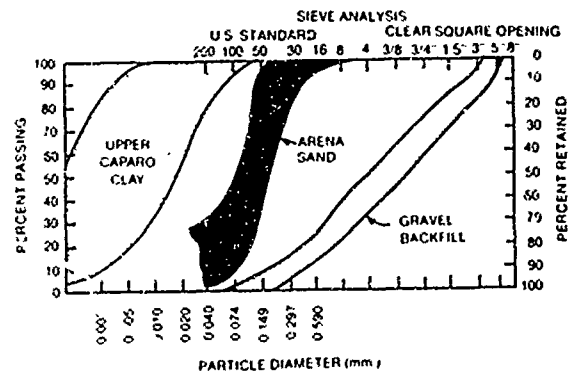
Fig. 6  
GRAIN SIZE DISTRIBUTIONS

Each conduit construction joint was provided with a center-bulb waterstop to allow extension without leakage. The conduit was surrounded with a 2-foot-thick zone of 2-inch-minus, well-graded, sandy gravel (Figure 6). This gravel acts as a filter for the sand, and is

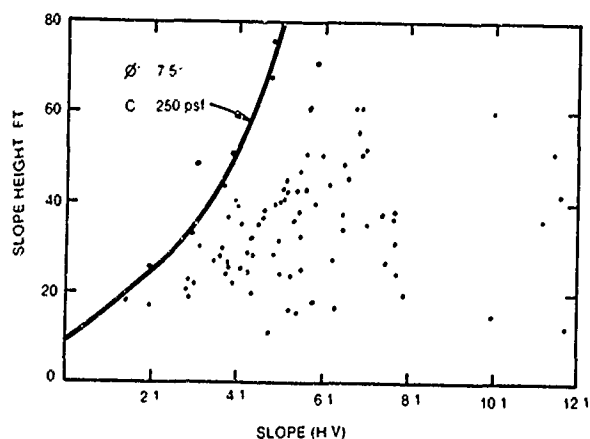
Fig. 7  
NATURAL SLOPES NEAR DAM

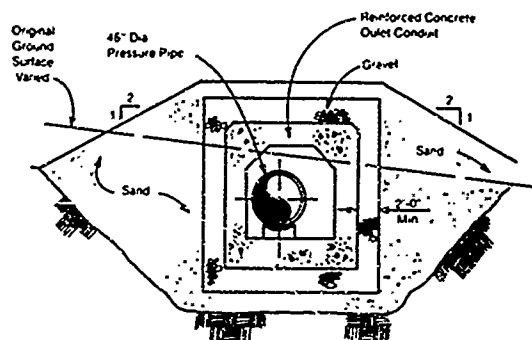
Fig. 8  
OUTLET CONDUIT SECTION

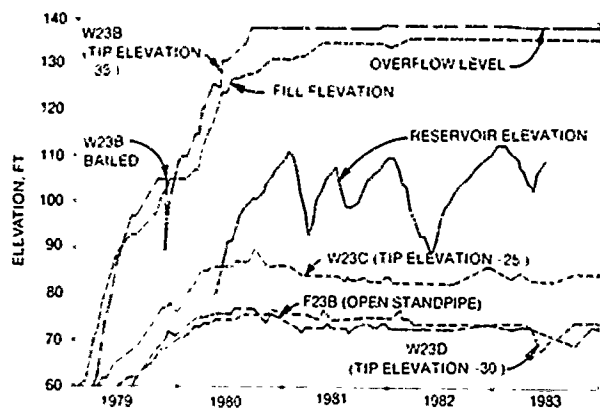
Fig. 9  
SELECTED EMBANKMENT PIEZOMETERS

The embankment performance was satisfactory and similar to the design assumptions. Figure 9

shows the results of pore pressure monitoring at four instruments and the rate of embankment construction at the instruments. The instrument locations are shown in Figure 2.

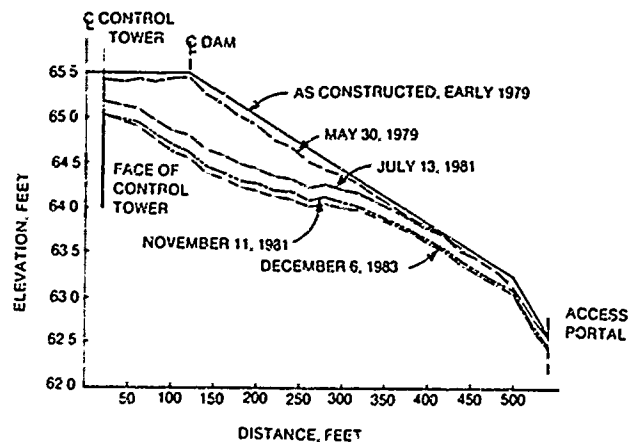
Fig. 10  
OUTLET CONDUIT SETTLEMENT

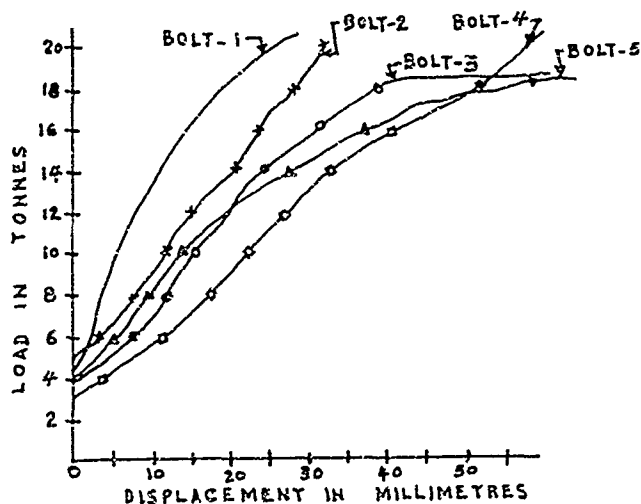
Fig.2 Rock bolt pull out test results

anchorage at a later stage. Ungrouted rock bolts were capable of taking 5 M.T. tensile load without any appreciable displacement.

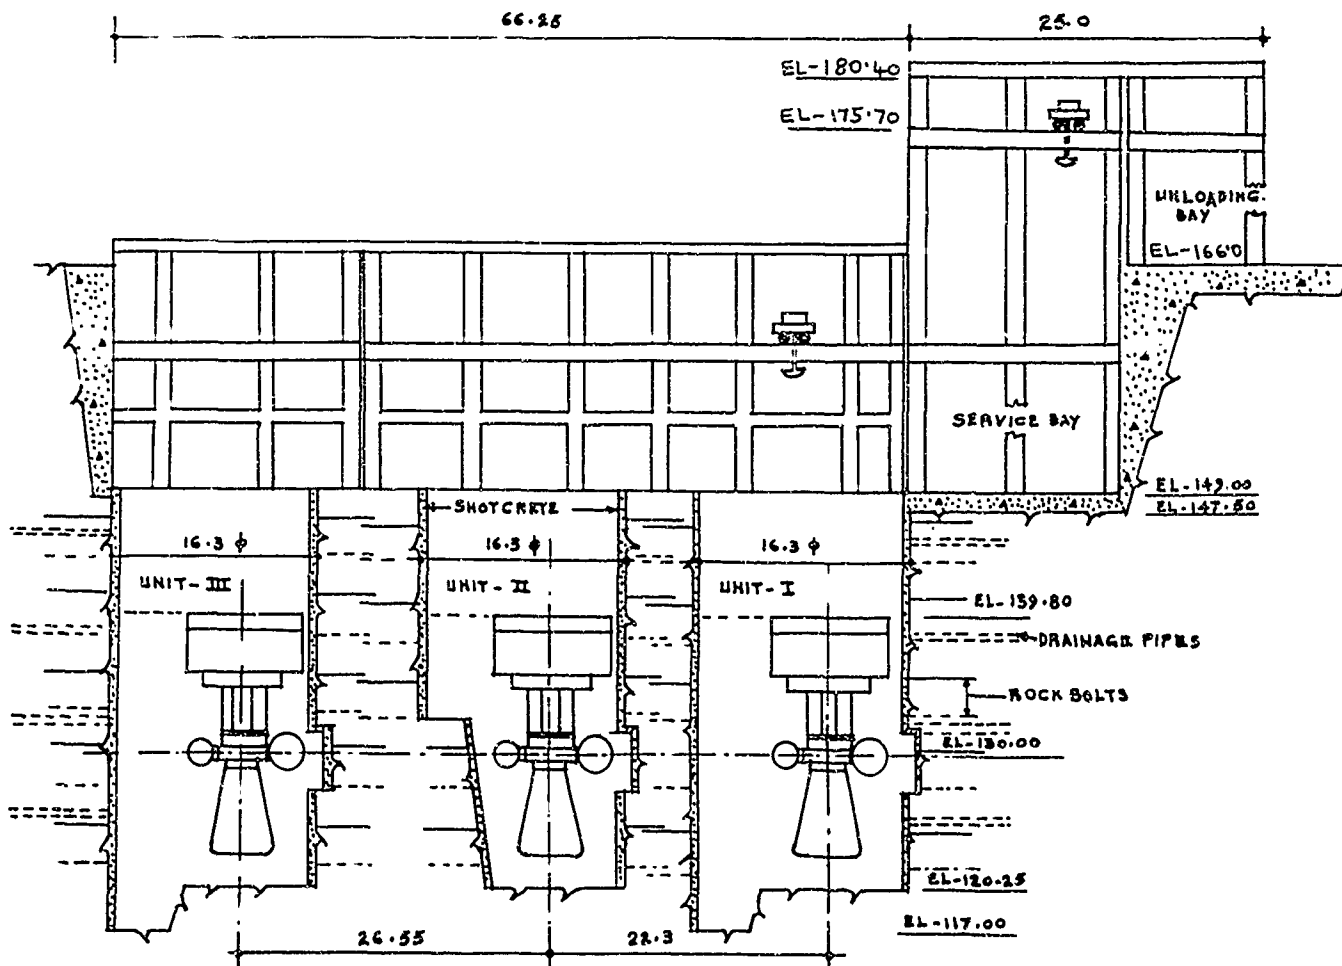
Fig. 3 Longitudinal section of power house.

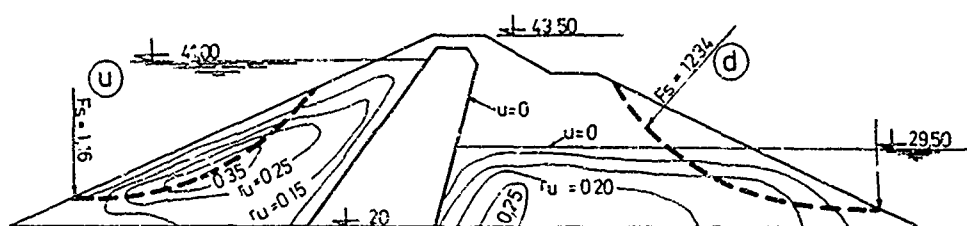
Fig.4. Pore Pressure Distribution After Earthquake and Stability Analysis.

used to evaluate pore water pressure ratios ( $ru$ ) distribution in both upstream and downstream shell. Pore water ratio distribution immediately after earthquake ( $M=7.2$ ) would have the approximate form shown in Figure 4. A stability computation using Bishop's modified method with residual porewater pressures (maximum values) when the shaking has stopped using an effective stress approach, indicates a minimum factor of  $Fs=1.16$  for critical circle upstream, compared with the minimum values of  $Fs=1.28$  from pseudo-static analysis ( $\alpha = 0.15$  g). It has been pointed out that most critical condition may not occur during the earthquake itself but sometime later when the pore water pressure attains its maximum value (Popovici et al., 1984). In downstream shell the pseudo-static analysis underestimates the stability. It may therefore be concluded that the dam is safe against the development of a major slide but the next step is to assess the magnitude of embankment deformations during the maximum possible earthquake.

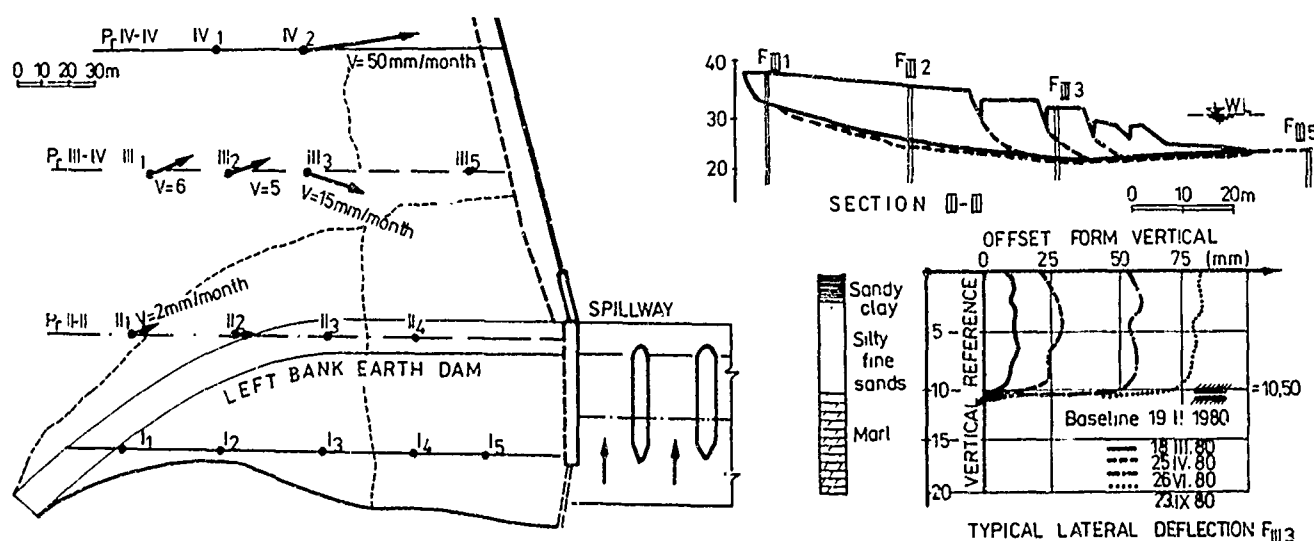
The slope indicator casings and piezometers were installed through the location of the failure area and a monitoring program instigated for further construction. The SINCO inclinometers are used to measure inclination of the drillhole. The shape of the slope indicator casing indicated that failure surface was at the boundary between bedrock and overlain formation consisting of a sequence of silty clays and silty fine sands as shown also in Figure 5.

Fig.5. Left Riverbank Landslides Monitoring.

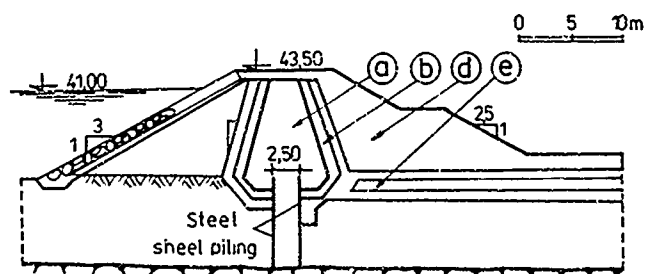
The left bank earthfill dam was designed for compatibility with the characteristics of the available foundation: part on bedrock (unweathered soft marl) rising to the surface, part on the riverbank alluvials with thickness from a few meter to more than 20 m. A typical profile within the dam on stiff bedrock differs from the ones within the left portion of dam overlying the riverbank deposits (Fig.6).

Fig.6. Earth Dam. Leftbank Connection.

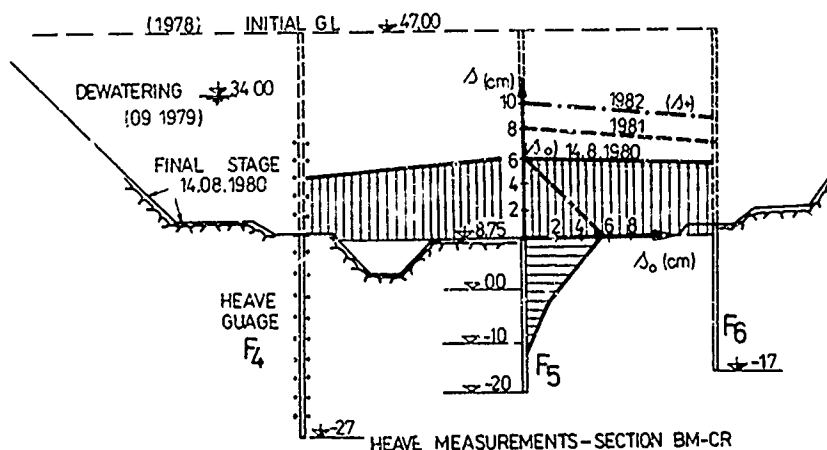
Fig.7. Field Measurements of Foundation Heave During Excavations.

10 cm was observed at gauge F 5 while the heave recorded in the spillway dam foundation was considerably less, being around of 0.5 cm. Plot of heave measurements versus pressures at various times are given in Figure 7 for profile with maximum depth of excavation (BM-R). A good correlation between the amount of the measured heave and the depth of excavation was observed, suggesting that the rebound was generally of a pseudo-elastic nature. An average field deformation modulus of 200 MPa was evaluated for the excavation stage. Factors such as the variation of rock properties across the site, and the "berm effect" (Klym et al., 1977) associated with excavated slopes were probably responsible for some discrepancies observed. The swelling process was also governed by the significant changes in pore pressures during dewatering and long time excavation schedules.

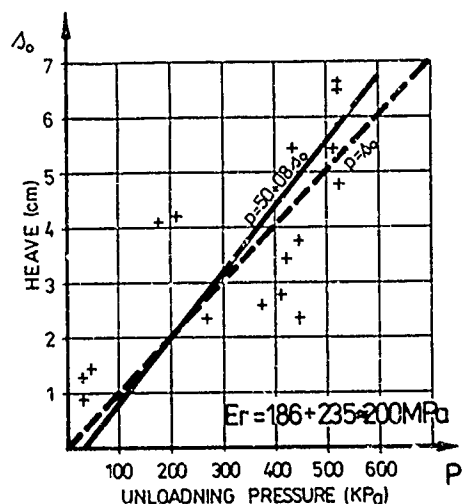
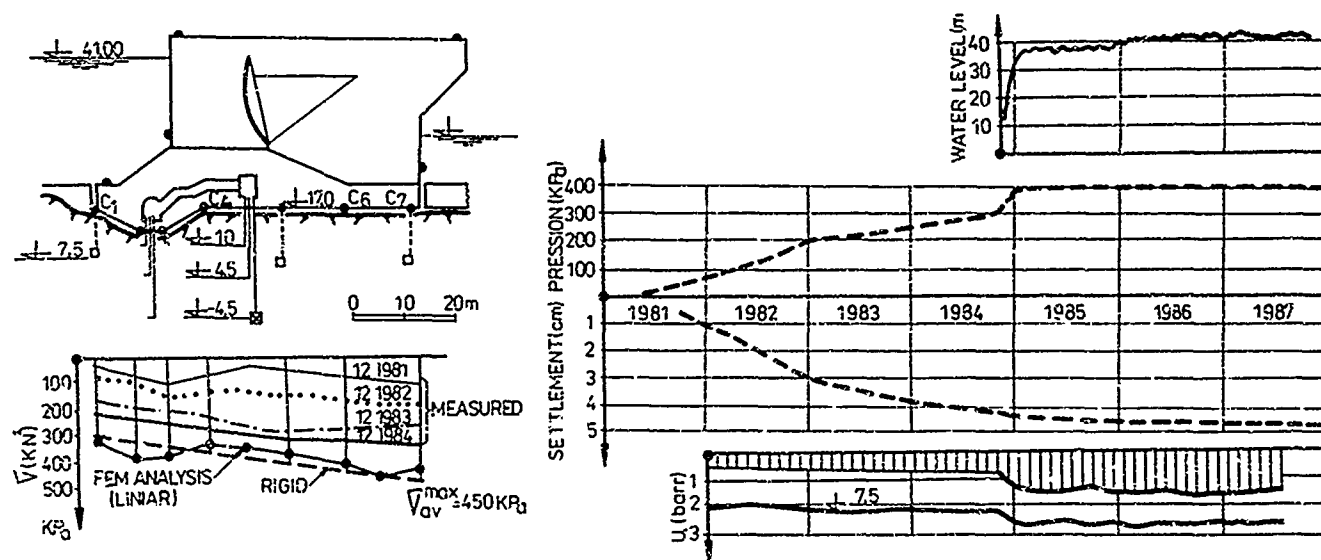
Fig.8. Spillway Dam Instrumentation Settlement and Total Pressure Recording.

During construction a complementary system of survey targets on the upstream and downstream face of concrete block makes possible to get by direct levelling the value of vertical foundation displacement at various phases of construction. The spillway dam instrumentation scheme and foundation settlement versus load during concreting schedules, impounding, reservoir filling and the first operational years are presented in Figure 8.

The yield deformation modulus evaluated during construction is of 200 MPa for layer I (upper) and 250 MPa for intermediate stiff clay layer. There are presented recorded pressure on foundation base (level 12 mdm) and comparison between field measurements and calculated results.

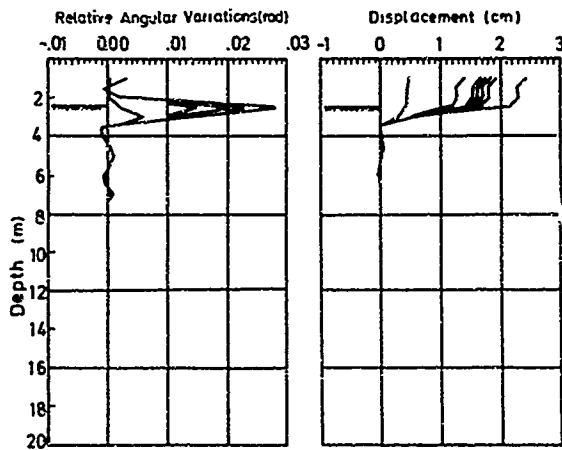
Figure 9 shows the angular variation and the resulted horizontal displacement for inclinometer B2 during the period 18.4.1985 and 19.2.1987, whereas in Figure 10 the total horizontal displacement ( $N6^\circ E$  direction) with time, is illustrated. The data from the inclinometers B6, B8 and B9, installed eastern from the semi-bridge (Figure 1) showed the same type of sliding as above in a depth of about 7.5 - 8.5 m below the surface of the new road. On the contrary, inclinometer B7 showed no evidence of sliding and so it could be considered that the location of this inclinometer is out of the limit of the observed landslide. Surface surveying which is still in progress showed a definite horizontal displacement of slope surface only in the narrow area of B6, B8 and B9 inclinometers and also a differential movement of the wing-walls of the semi-bridge.

Fig. 9 Movement of Inclinator B2

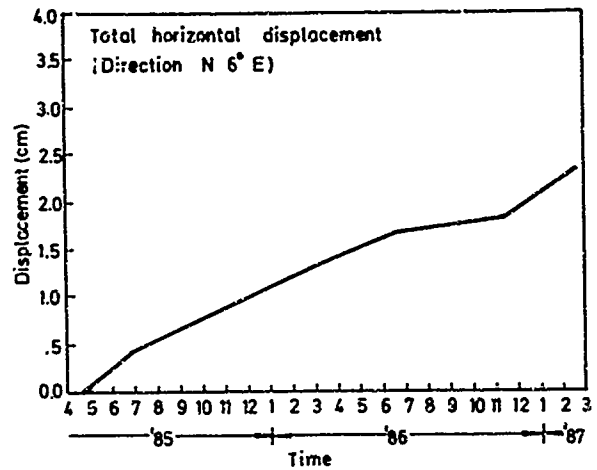
Fig. 10 Total Horizontal Displacement of Inclinator B2 with Time

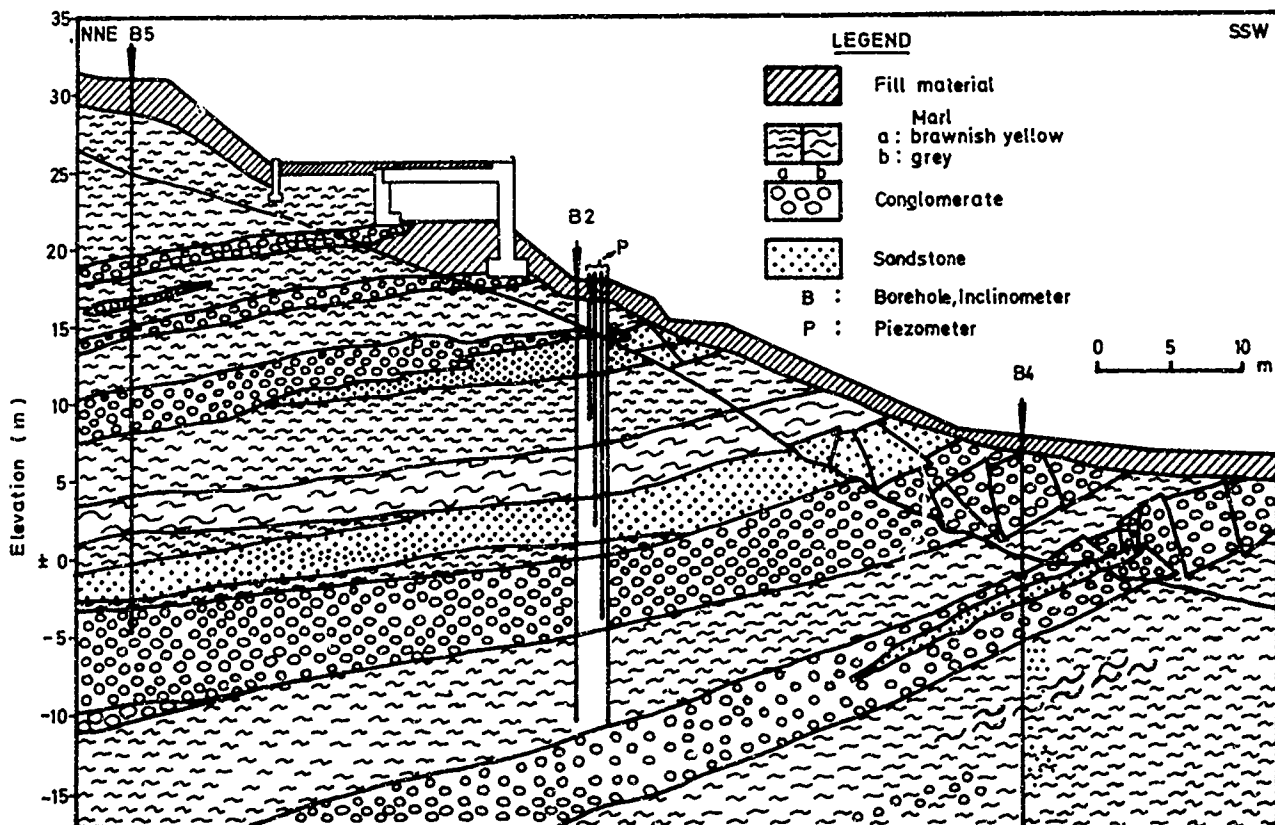
On the basis of the geological data, the logs of boreholes and inclinometers data, the geological cross section across the inclinometers B5, B2 and B4, of a direction NNE to SSW, was able to be drawn as it is illustrated in Figure 11. As is shown in this Figure the slip surface is a rather undulating one which crosses the marl layers as well as the layers of conglomerates and sandstones. It must be noted that sliding takes place

through the mass of marls, but the sliding surface follows the joints and cracks of conglomerates and sandstones which are mainly subjected to extension and not to shearing. It is believed that the structure of the conglomerates and sandstones above the sliding surface has been disturbed due probably to an old landslide.

Fig. 11 Geological Cross Section and Location of Slip Surface

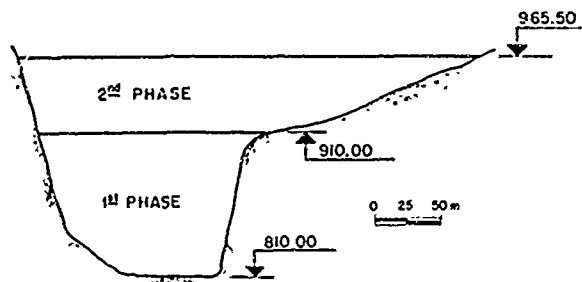
Analysis was carried out in two stages, coinciding with the project's two technical phases: First technical phase (up to elevation 910) and second technical phase up to termination of the construction (elevation 965.5), Fig. 2.

FIG.2 LONGITUDINAL PROFILE ALONG THE DAM AXIS

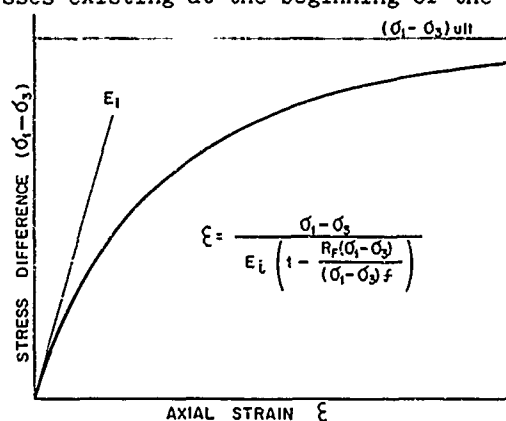
The deformability modules used by the programme are variable with the level of material deformation and confinement pressure. Specifically, the stress-deformation model proposed by Kodner and Zelasco (1963) and Duncan (1970) and better known as the "hyperbolic model" is used, Fig. 4.

FIG.4 HYPERBOLIC MODEL

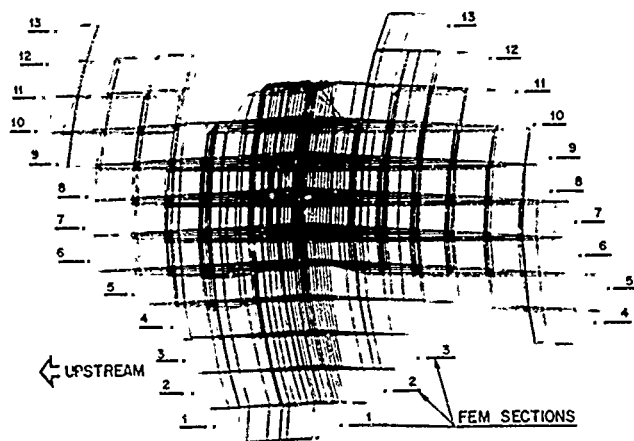
The number of elements into which the Dam was simulated was 556, with a total of 842 nodes, Fig. 5.

FIG. 5 DIAGRAM OF FINITE ELEMENTS MESH (FEM)

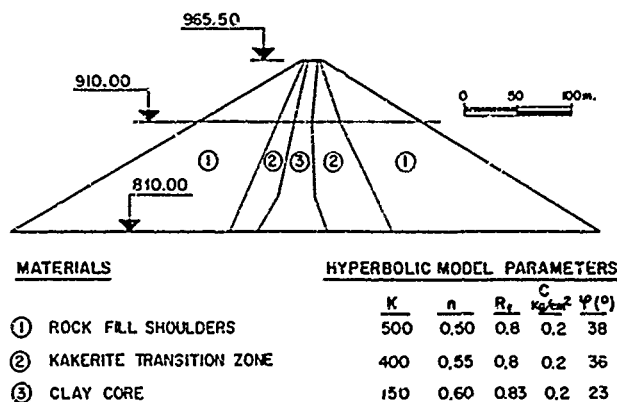
c. Materials characterization (Fig. 6). In order to determine the resistance and deformation parameters needed for calculation, the following process was used:

FIG. 6 TYPICAL DAM CROSS-SECTION

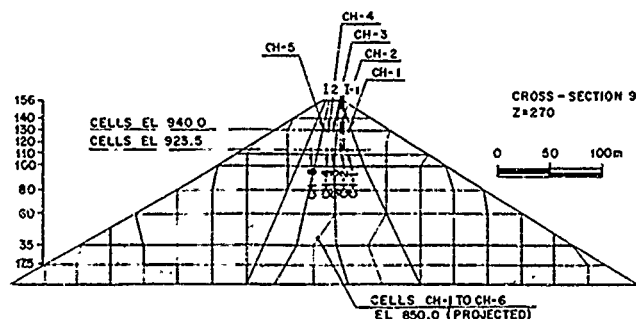
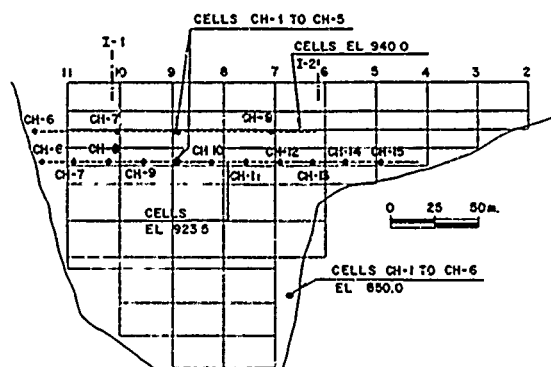
The cells are located on three levels at elevations 850.0, 923.5 and 940.0

Inclinometers I1 and I2 are located in the vicinity of the left and right hand banks respectively.

a) TRANSVERSAL CROSS-SECTION

b) LONGITUDINAL SECTION

FIG. 7 LOCATION OF SETTLEMENT CELLS AND INCLINOMETERS

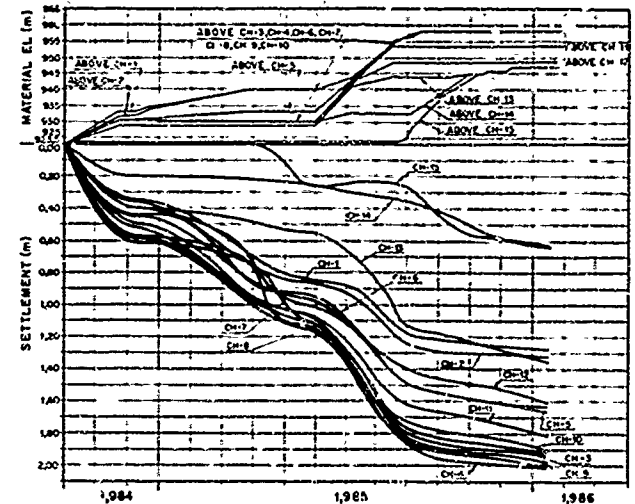
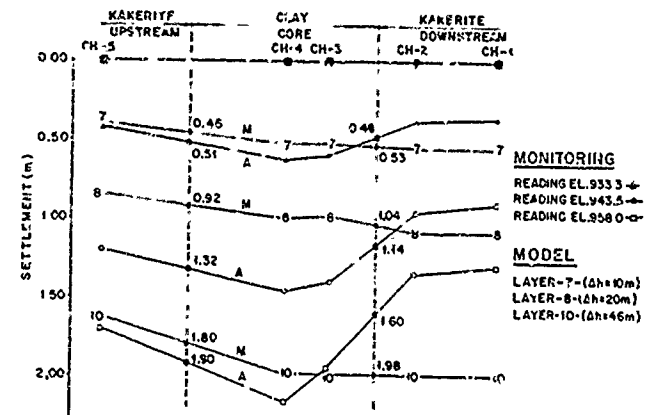
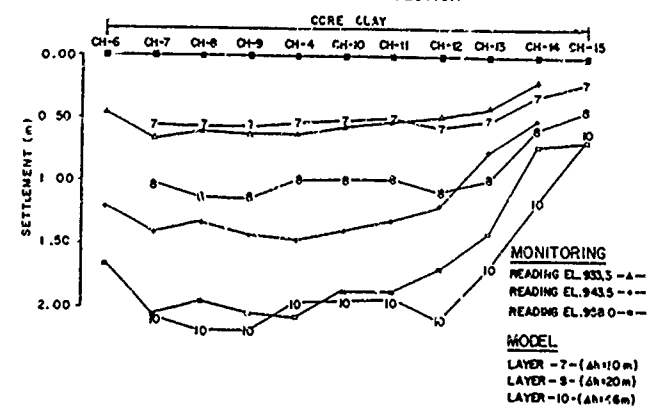
### a) READINGS FROM CELLS EL. 923.5

### b) CONTRAST IN TRANSVERSAL CROSS-SECTION

### c) CONTRAST IN LONGITUDINAL-SECTION

Fig. 8 CELLS EL. 923.5 MODEL-MONITORING SISTEM CONTRAST

- Elevation 923.5, Fig. 8. Contrasts were carried

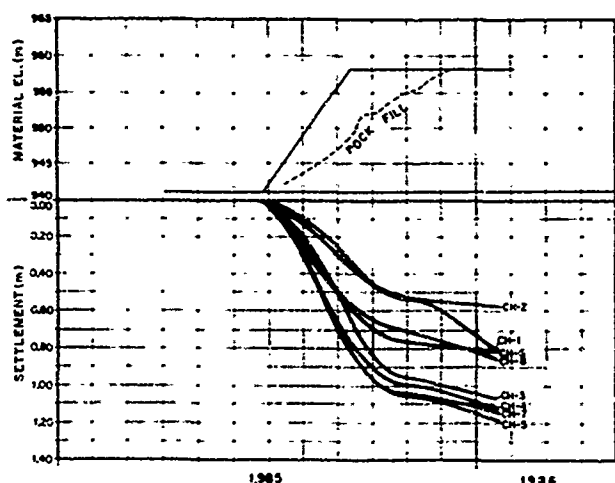
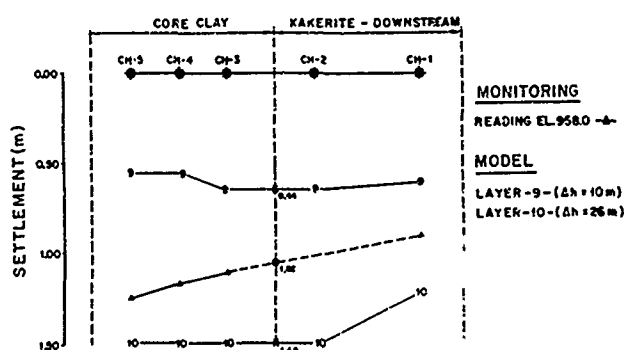
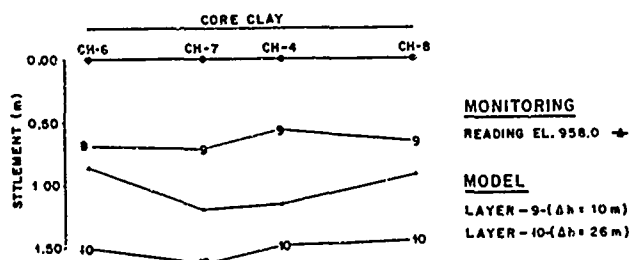
Fig. 9. CELLS EL. 940.0 MODEL-MONITORING SYSTEM CONTRAST

a) READINGS FROM CELLS EL. 940.0

b) CONTRAST IN TRANSVERSAL CROSS-SECTION

c) CONTRAST IN LONGITUDINAL-SECTION CORE CLAY

In the transversal cross-section, where the significant comparison values are those corresponding to the Dam core-kakerite contact points, the most significant points of contrast are the following:

1. For an overload of 10m, contrast is good with deviations below 10%.
2. For an overload of 20m, the above values are maintained downstream, while upstream the deviation reaches 30%.

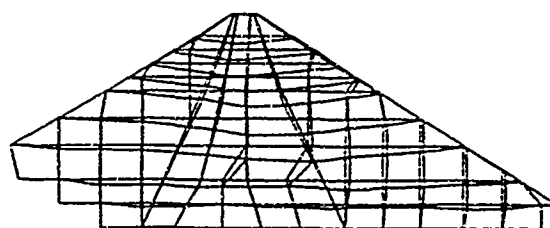
Fig. 10 DEFORMED TYPE TRANSVERSAL CROSS-SECTION

In order to obtain an overall idea of the behaviour of the Dam at the end of construction time, a deformation diagram of the central section of the Dam has been drawn, Fig. 10. along with the vertical and horizontal iso-displacements lines and a longitudinal cross-section along the axis of the core, Figs. 11 and 12.

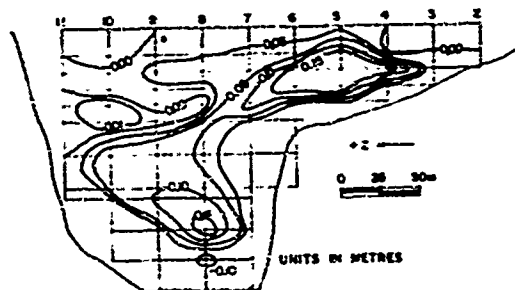
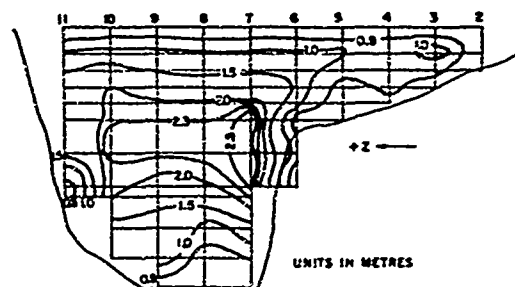
a) ISO-LINES FOR HORIZONTAL MOVEMENTS Z

b) SETTLEMENT ISO-LINES

Fig. 12 LONGITUDINAL CROSS-SECTION.MOVEMENTS

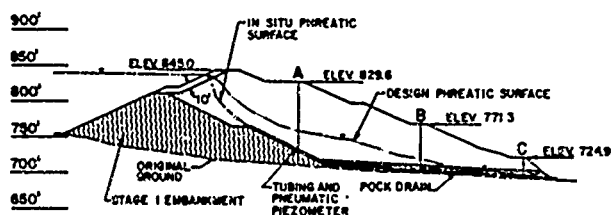
**Fig. 2 Cross-Section of the Embankment at the Time of the Study**

A phreatic surface was calculated using a standard Casagrande construction. The phreatic surface for the design is as shown on Figure 2. An assumption was made in this calculation that the permeability of the coarse refuse was 100 times that of the slurry and that the horizontal permeability of the coarse refuse was equal to four times the vertical permeability. A 10-foot thick cohesive cover and a rock drain were designed to control seepage.

The above information was used to plot the actual phreatic surface in-situ. It can be seen from Figure 2 that the actual phreatic conditions within the embankment are much lower than those assumed during design. This is partially because the design conditions considered the embankment to be retaining water when in actual fact the embankment retains fine refuse which in itself has a relatively low permeability. There is very little water actually perched on top of the slurry and the actual flow conditions are considerably less than those calculated by assuming the embankment to be retaining water.

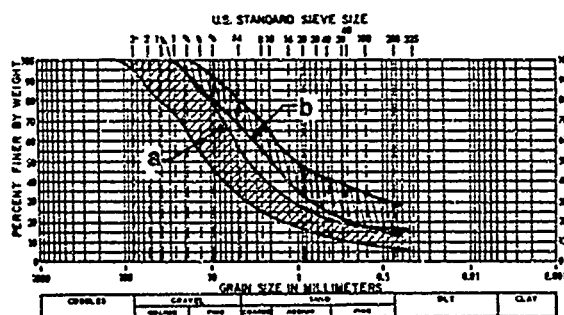
**Fig. 3 Gradation Range for Refuse: a. Design; b. In-Situ**

Figure 3 shows the gradation range (a) of the coarse refuse as initially tested.

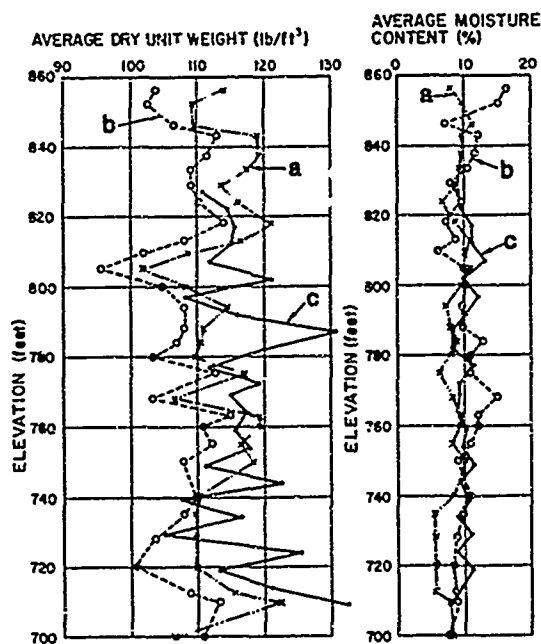
Fig. 4 Results of Measurements: a. Laboratory Standard Proctor; b. As-Compacted Values; c. In-Situ Measurements After Completion of the Embankment

Approximately 214 density tests have been performed as a part of the inspection program to date. The average of those tests for each 5-foot lift of refuse are plotted on Figure 4.

As the refuse was being placed the character changed from time to time and standard Proctor tests were periodically performed to achieve proper control of the placement. A total of thirty-five standard Proctor tests have been performed. The average values for 5-foot lifts are shown in Figure 4.

The density and moisture content were determined with the nuclear gauge every foot throughout the embankment. A total of 120 density and moisture content determinations of the in-situ material were made during this study. Figure 4 shows the average density and moisture contents for each 5-foot increment throughout the depth of the embankment. The percentages for compaction shown in Figure 5 were calculated by utilizing appropriate standard Proctor curves for the various elevations of refuse from the initial inspection data. It can be calculated from Figure 5 that the following average conditions exist in the embankment to date (Table III).

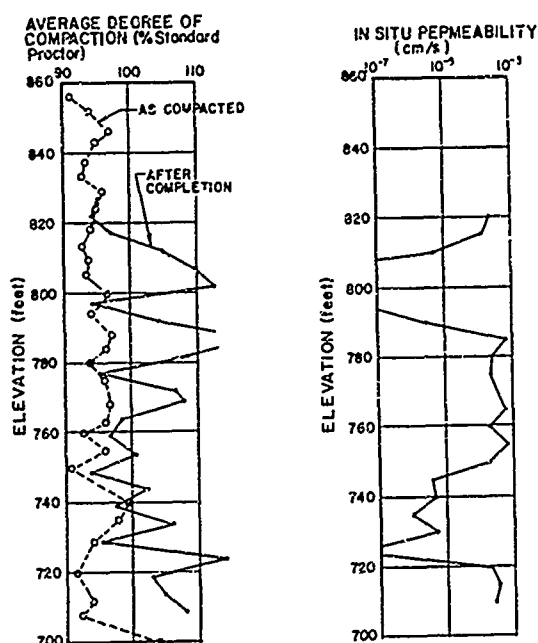
Fig. 5 Results of In-Situ Measurements

Very little correlation between permeability and percent compaction within the coarse refuse embankment was noted. The permeabilities were performed continuously from top to bottom and coincided with various different densities. Figure 5 shows the plots of degree of compaction and permeability. It will be noted from Figure 5 that higher permeabilities do not necessarily coincide with lower densities, nor do lower permeabilities coincide with higher densities. The greater effect on permeability for coarse refuse is the grain size distribution, not the degree of compaction. Coarse refuse is basically a sand and gravel with a percentage of fines. The data shows percentage of fines in relationship to the percentage of the other size fractions within the total mix is what controls the permeability of the coarse refuse. Table VII shows the average permeability versus density and percentage of each fraction for each 5-foot level throughout the embankment.

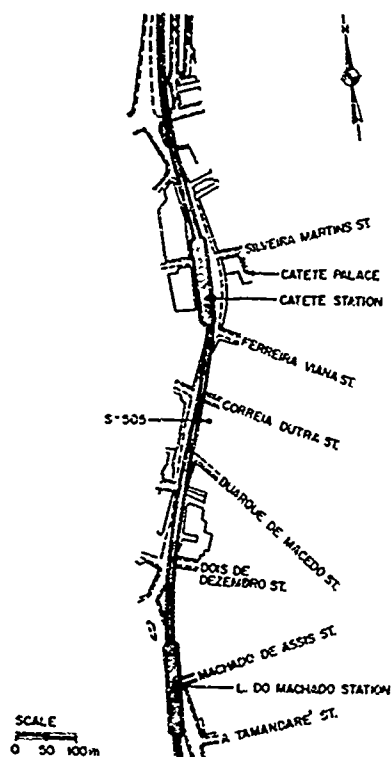
Fig. 1. Rio de Janeiro Subway General View at Catete Street

Part of the Rio de Janeiro city subway first line passes below Catete Street and joins Largo do Machado Station to Catete Station, in an area where several small streets and old buildings exist (Figure 1). A cross-section of this part is shown in Figure 2. The field and laboratory data available corresponding to the stretch between Ferreira Viana and Dois de Dezembro streets (Figure 1). In this region, borehole number S-505 was considered to be the most representative and its corresponding geotechnical profile is shown in Figure 3. As can be seen in this figure, the first layer is a fill that has an average thickness of 4 metres, an average blow-count number,  $N(SPT)$ , of 10 and liquid limit (LL) and plastic index (PI) equal to 20% and 10%, respectively. Underlying this fill, there is a 10 metre thick uniform, fine to medium sand layer in which the first 3 metres is in a dense state, relative density ( $D_r$ ) between 75% and 85%, and the last 7 metres are in a loose state ( $D_r$  between 25% and 35%). These relative density values were obtained correcting the  $N(SPT)$  according to the vertical effective pressure (Gibbs and Holtz, 1957 and Teng, 1972).

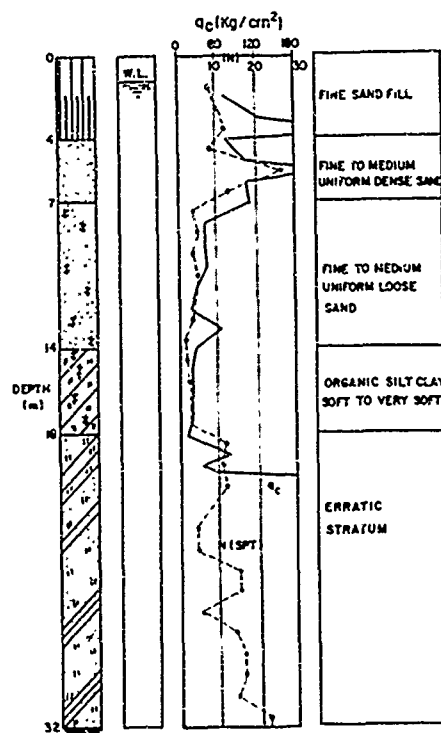
Fig. 3. Geotechnical Profile at Borehole S-505
